NASA TM X-2408

THE MANNED SPACECRAFT CENTER GEMINI
MICROMETEORITE-COLLECTION EXPERIMENT

by Robert E. Flaherty

Manned Spacecraft Center

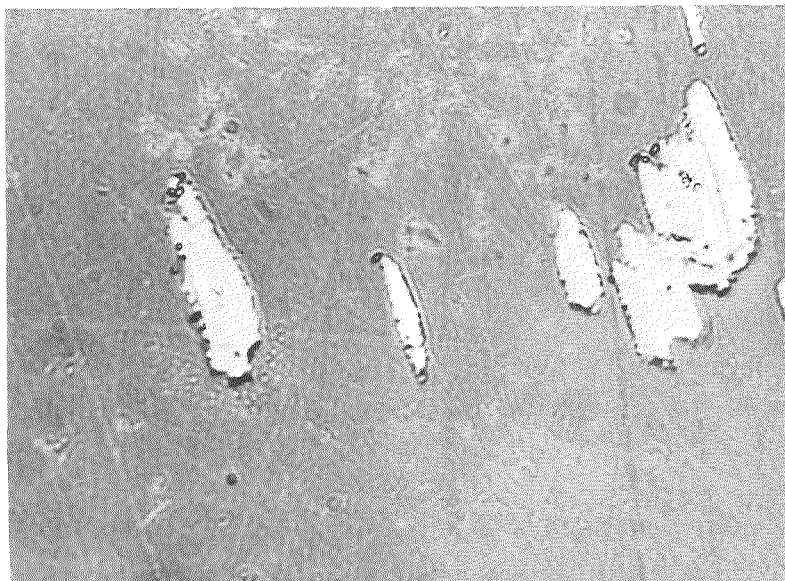
Group 8 is defined as areas of oblong defects in the aluminum film, ranging in size from 4 by 15 microns to 15 by 30 microns. These defects are only in the aluminum film, and there is no apparent damage to the Plexiglas surface. Each of these oblong defects has an associated ring of contaminants. Multiple and complex ring structures of contamination are visible in areas of multiple defects. This effect is shown in figure 22.

Figure 22. - A $\times 765$ view of multiple defects. (Note how aluminum is pushed toward the edges.)

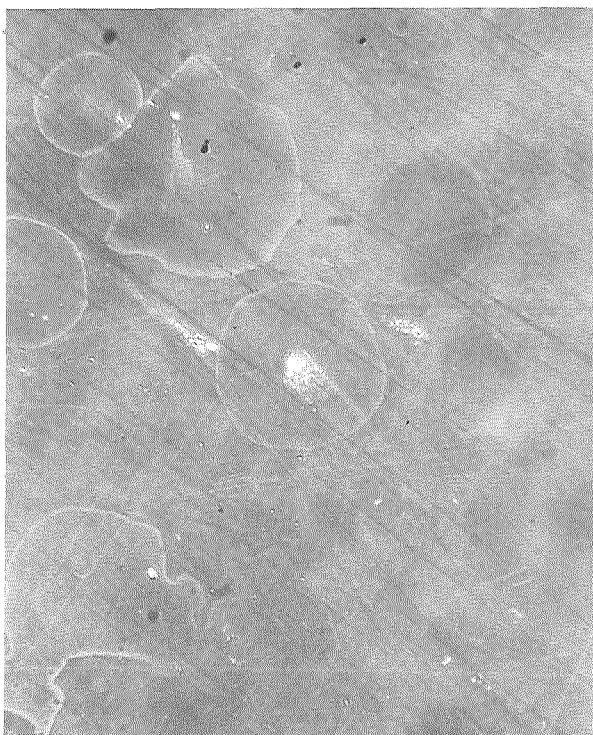
Group 9 is defined as areas of high contamination showing evidence of an evaporated liquid that has left a translucent deposit on the aluminum surface. Often, the aluminum film in the central region of the deposit has been etched away. This effect is also found on the edge of some other translucent regions. These effects are shown in figures 23 to 25. Other translucent regions were found that had no effect on the aluminum film, as shown in figure 26.

Figure 23. - A $\times 200$ view of area with center etched away.

Figure 24. - A $\times 200$ view of area with edges etched away.

Figure 25. - A $\times 765$ view of irregular etched effect.

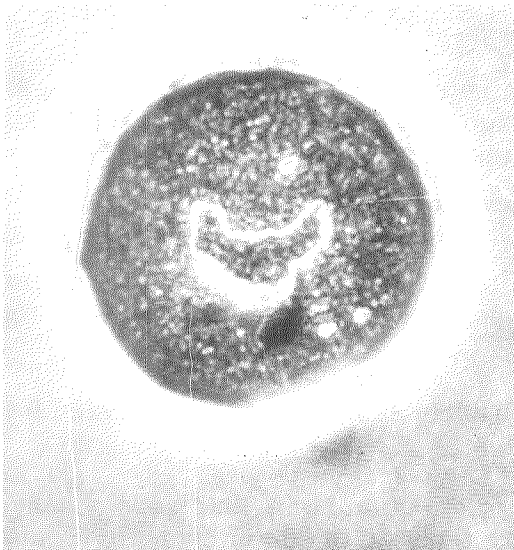
Group 2a includes large areas of multiple holes in the aluminum film. Most of these effects are irregular; however, some have a very circular profile (figs. 33 and 34). All of these holes have very steep sides through the 10 microns of aluminum, and some have residue in the bottom. At magnifications up to $\times 765$, there was no visible damage to the stainless steel surface. Several effects, with numerous particles adhering to the aluminum surface, are shown in figure 35; the photomicrograph in figure 36 was taken 2 months later. (Note that the particles have disappeared, leaving holes in the aluminum film. The holes conform to the shape of the corresponding particles.) This group-2a effect was also observed on the backup sample, but to a lesser extent, and is shown in figures 37 and 38.

Figure 33. - A $\times 765$ view of 40-micron-diameter hole in aluminum, focused on residue in bottom.

Figure 34. - A $\times 765$ view of 40-micron-diameter hole in aluminum, focused on top surface of aluminum.
